**Twenty Four
Carbondale, CO**

Report #: 21306-1
Beginning: January 1, 2023
Expires: December 31, 2023

**RESERVE STUDY
Update "With-Site-Visit"**

March 15, 2023

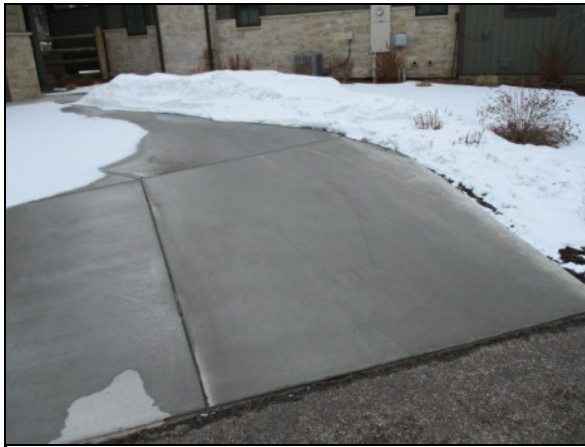
Comp #: 21090 Conc. Walks & Drives - Repair - 5%

Comments: Concrete sidewalks and driveways determined to be in fair condition typically exhibit minor changes in slope and a moderate percentage of cracking and surface wear. Due to the progressive nature of build dates, a concrete allowance provides ongoing funds for maintaining the concrete. This assumes partial repair and replace as opposed to full replacement.

Trip hazards may be increasing in frequency and severity and should be closely monitored to prevent further risks. The Rocky Mountain Region is home to expansive soils. One of the causes of concrete damage in this type of soil moisture. Expansive soils tend to swell in size when wet and contract as they dry out. As the soil expands and contracts it can create enough force to cause major damage to sidewalks. Repair any trip and fall hazards immediately to ensure safety. As routine maintenance inspect regularly pressure wash for appearance and repair promptly as needed to prevent water penetrating into the base and causing further damage. In our experience larger repair/replacement expenses emerge as the community ages. Although difficult to predict timing cost and scope we suggest a rotating funding allowance to supplement the operating/maintenance budget for periodic larger repairs. Adjust as conditions actual expense patterns dictate within future reserve study updates.

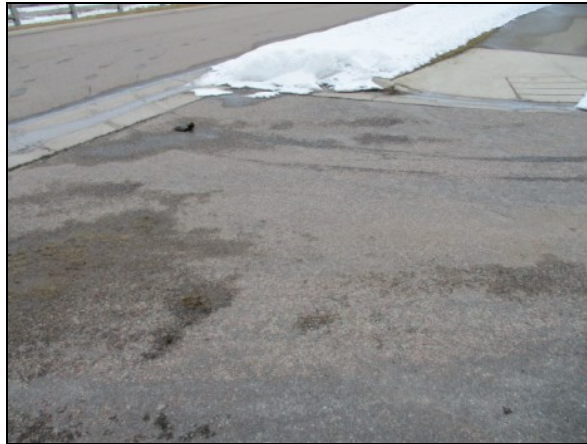
Comp #: 21190 Asphalt - Seal/Repair

Comments: Significant deterioration of asphalt observed due to lack of seal cycle. Asphalt seal was observed to be in poor condition at the time of the inspection. The seal appeared to be weathered and faded. Exposed aggregate and a gravelly texture was noted. Plan to seal the asphalt soon. Regular cycles of seal coating (along with any needed repair) has proven to be the best program in our opinion for the long term care of lower traffic asphalt areas such as these. The primary reason to seal coat asphalt pavement is to protect the pavement from the deteriorating effects of sun and water. When asphalt pavement is exposed the asphalt oxidizes or hardens which causes the pavement to become more brittle. As a result the pavement will be more likely to crack because it is unable to bend and flex when subjected to traffic and temperature changes. A seal coat combats this situation by providing a waterproof membrane which not only slows down the oxidation process but also helps the pavement to shed water preventing it from entering the base material. Seal coat also provides uniform appearance concealing the inevitable patching and repairs which accumulate over time. Seal coat ultimately extends useful life of asphalt postponing the asphalt resurfacing which can be one of the larger cost items in this study (see component #21200 for asphalt resurfacing costs). Repair asphalt before seal coating. Surface preparation and dry weather during and following application is key to lasting performance. The ideal conditions are a warm sunny day with low humidity rain can cause major problems when seal coating and should never be done when showers are threatening. Incorporate any striping and curb repair into this project. Fill cracks and clean oil stains promptly in between cycles as routine maintenance. Prior to a seal coat application the areas will be cleaned with push blowers and wire brooms. Be aware that sealcoat will not adhere to heavily saturated oil spots. Vendors typically recommend infrared patching on areas with saturated oil spots to ensure adherence of sealcoat.

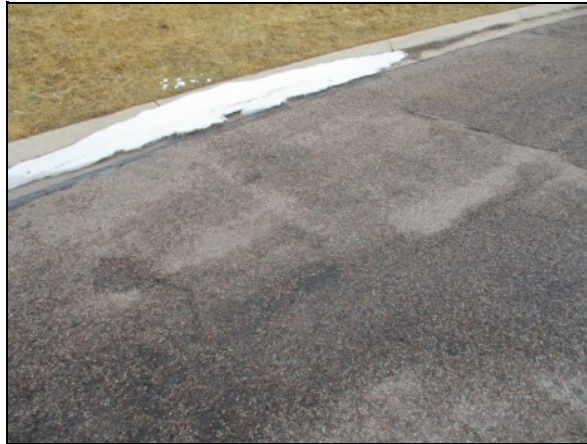
Comments: Spalling and crumbling observed. Asphalt pavement determined to be in poor condition typically exhibits more substantial consistent patterns of wear and age including longer wider cracks and/or patterns of cracking. Raveling is more advanced resulting in dimpled rougher texture over most (if not all) areas. Color has faded and curb appeal is declining. At this stage timeline for resurfacing should be discussed and proper scope of work developed. Useful life below assumes regular seal coating and repairs. The lack of seal coating and repairs can greatly decrease the asphalt's useful life. Resurfacing is typically one of the larger expense items in a reserve study. When need to resurface is apparent within a couple of years consult with geotechnical engineer for recommendations specifications / scope of work and project oversight. As routine maintenance keep surfaces clean and free of debris ensure that drains are free flowing repair cracks and clean oil stains promptly. Assuming proactive maintenance plan to resurface at roughly the time frame below. If regular maintenance and sealing is deferred client may need more extensive repair and replacement projects. Funding below assumes that asphalt has adequate subgrade as well as asphalt fill depth. If fill depth is less than 2" client may need to consider a remove and replacement project which can increase costs by 50% or more. Further resources: Pavement Surface Condition Field Rating Manual for Asphalt Pavement. <http://co-asphalt.com/resources/maintenance-and-preservation/>

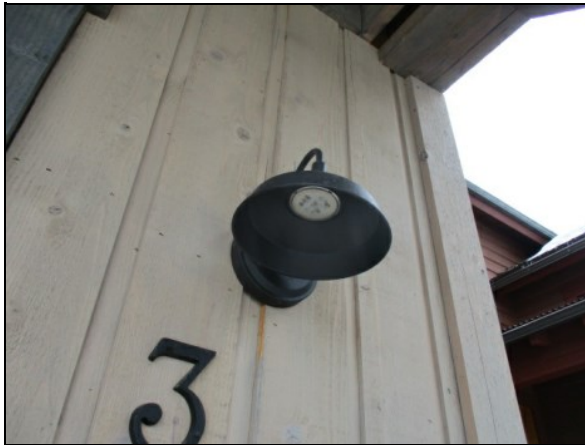
Comp #: 23020 Ext. Lights - Replace

Comments: Replacing exterior components collectively provides cost efficiencies and economies of scale. Plan to replace the following components in Building Exteriors chapter together in order to achieve aesthetic consistency and fiscal efficiency.

Exterior lights determined to be in fair condition typically exhibit more moderate signs of wear and age but are generally believed to be aging normally with no unusual conditions noted. Observed during daylight hours but assumed to be in functional operating condition. As routine maintenance clean by wiping down with an appropriate cleaner change bulbs and repair as needed. Best practice is to plan for replacement of all lighting together at roughly the time frame below for cost efficiency and consistent quality/appearance throughout development. Should be coordinated with exterior painting projects whenever possible. Individual replacements should be considered an Operating expense. If available an extra supply of replacement fixtures should be kept on-site to allow for prompt replacement.

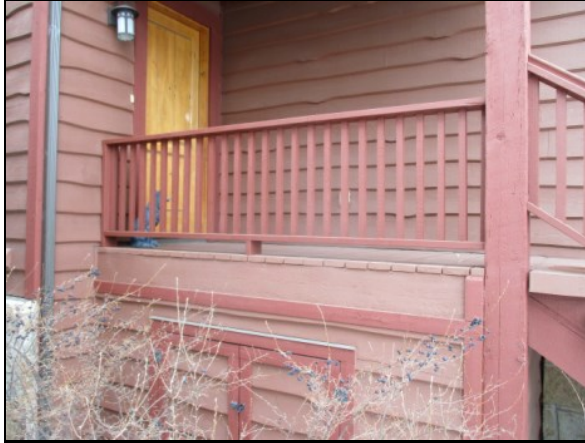
Comp #: 23190 Wood Deck - Seal/Repair

Comments: The finish on the deck surfaces appeared in fair condition. Minimal evidence of cracking fading and peeling of the paint/stain was observed. Wood seal coatings lose thickness each year due to wear and exposure to UV light. If more than the topcoat is allowed to wear off the surface may still appear to be in 'good' condition to the untrained eye but waterproof integrity may be compromised. Decks should be thoroughly evaluated by a decking or waterproofing contractor prior to re-coating in order to determine scope of any required repairs. If the deck system has a warranty the client should make sure to follow any requirements necessary to maintain said warranty such as re-coating at required intervals and conducting professional inspections. As a general rule potted plants and other items that may trap water should be elevated off the deck or used with a waterproof liner in order to prevent prolonged exposure.

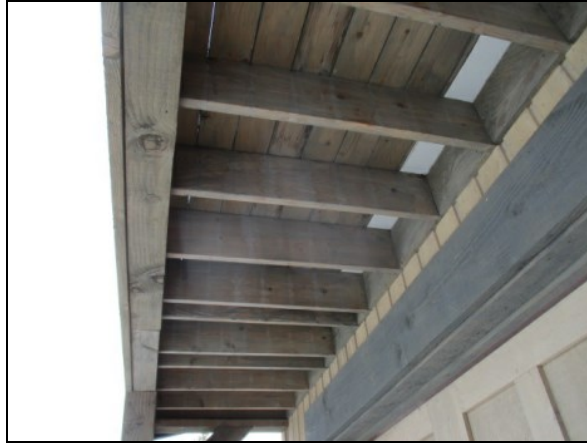
Comments: The deck surfaces appeared in fair condition. No broken or missing sections observed. Minimal evidence of cracking fading and peeling of the paint/stain was observed. Wood deck surface was painted/stained. No decay of boards was observed. Plan for large scale repair / replacement at roughly the interval below. As routine maintenance inspect deck stairs and railings annually and repair as needed. As part of maintenance apply water repellent stain/preservative at least every other year. Options for a longer lasting deck include such things as using a thick wood boards of suitable species or a composite product. Composite materials are available that require less maintenance and lower life cycle costs typically. Funding for replacing existing wood boards with in-kind material is factored below. Costs can increase greatly if decay of the structural framing is found.

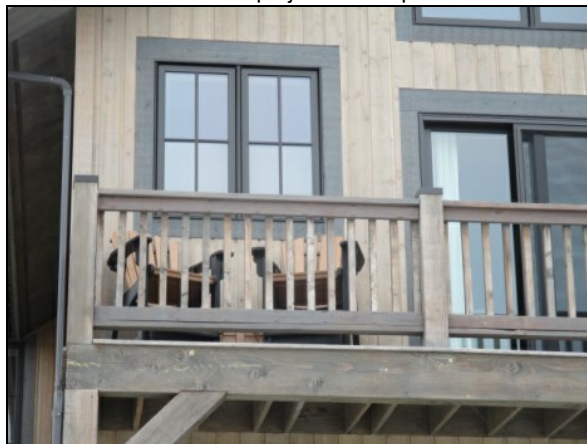
Comments: Deck railing finishes determined to be in fair condition typically exhibit minor to moderate wear with faded but consistent color. Coating is generally intact but may be beginning to peel or flake in sections. Railings should be painted/re-coated at the approximate interval shown below in order to restore good appearance and protect the railings from excessive surface wear. If railing is exposed to the elements without adequate coating for an extended period of time useful life may be severely reduced. Best practice is to coordinate with other exterior projects when possible such as deck re-coating or exterior painting.

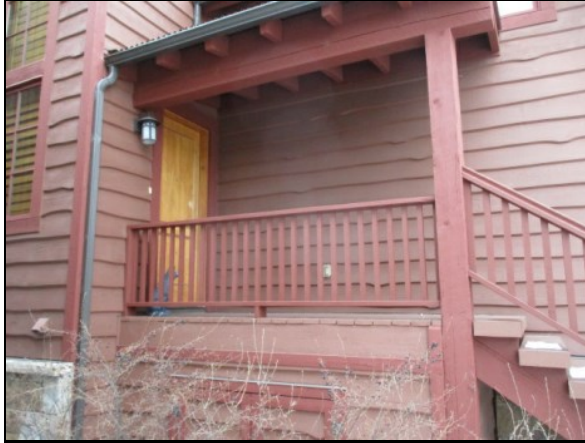
Comp #: 23230 Balcony Rails - Replace

Comments: Deck railings determined to be in fair condition typically exhibit some wear and age but are not showing any advanced structural concerns loose attachments rust etc. Appearance may be declining or outdated at this stage but railings are still performing their intended function. Post attachments and hardware should be inspected periodically for corrosion/rust and any waterproofing issues. As routine maintenance inspect regularly to ensure safety and stability repair promptly as needed using general operating/maintenance funds. We suggest Reserve funding for regular intervals of total replacement as indicated below. Unless otherwise noted costs shown are based on replacement with a similar style of railing. However if the client chooses to upgrade or replace with a different style costs may be substantially different. Any new information about changes in style should be incorporated into future Reserve Study updates.

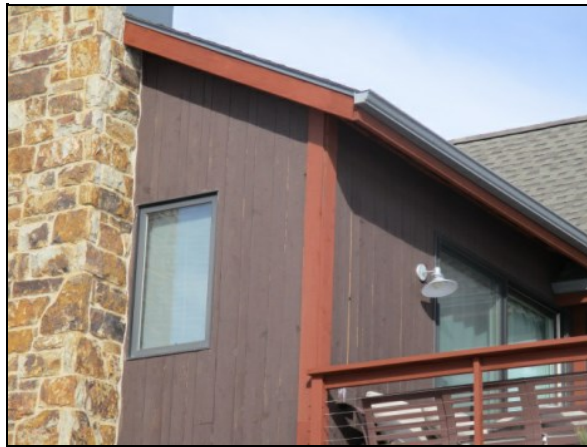
Comp #: 23310 Wood Siding – Repair/Repaint

Comments: Painted exterior surfaces determined to be in fair condition typically exhibit some minor to moderate signs of wear and age such as chalking peeling blistering etc. Problems tend to develop in more exposed areas first. Hairline cracks may be present at this stage. Overall appearance is satisfactory. As routine maintenance inspect regularly (including sealants) repair locally and touch-up paint as needed. Typical paint cycles can vary greatly depending upon many factors including type of material painted surface preparations quality of material application methods weather conditions during application moisture beneath paint and exposure to weather conditions. Proper sealant/caulking is critical to preventing water intrusion and resulting damage to the building structure. Incorrect installations of sealant are common and can greatly decrease its useful life. Inspect sealant more frequently as it ages to determine if it is failing. Typical sealant problems include failure of sealant to adhere to adjacent materials and tearing/splitting of the sealant itself. As sealants age and are exposure to ultra-violet sunlight they will dry out harden and lose their elastic ability. Remove and replace sealant as signs of failure begin to appear. Proper cleaning prep work and proper installation are critical for a long lasting sealant/caulking. Do not install sealant in locations that would block water drainage from behind the siding. Repair areas as needed prior to project. For best results the client may want to consult with a building envelope specialist or waterproofing contractor to specify types of materials to be used and define complete scope of work before bidding. Best practice is to coordinate this type of work with other projects whenever practical such as balcony sealing planter waterproofing etc.

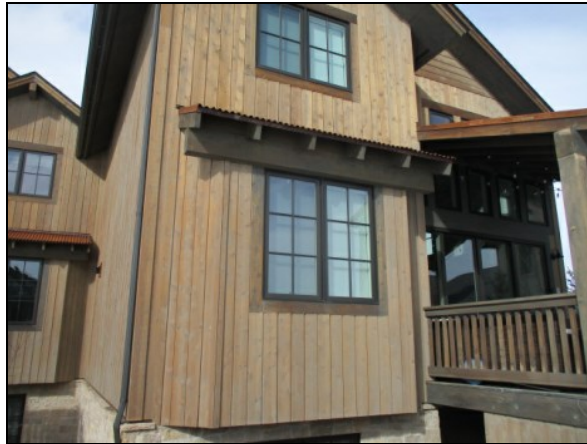
Comp #: 23320 Wood Siding - Replace

Comments: Wood siding determined to be in fair condition typically exhibits some color fading and inconsistency with minor isolated locations showing more advanced surface wear cracking splintering etc. Project costs can vary depending upon materials chosen and the condition of the underlying structural framing when exposed. We recommend the Board conduct research well in advance in order to define scope timing and costs including plan for some margin of contingency. Siding is horizontal clapboard, vertical clapboard, and shingle. Surface was painted and/or stained. No view of the critical underlying waterproofing was available as part of our limited visual review. Replacement may ultimately be needed due to the failure of the underlying waterproofing degrading over the decades and/or the end of the useful life of the siding materials from general aging. Many factors influence the useful life including exposure to (or protection from) wind driven rain and the quality of the waterproofing and flashing beneath the siding. Evaluate the siding and the critical underlying waterproofing (typically building paper or house-wrap) more frequently as the remaining useful life approaches zero years. Adjust remaining useful life as dictated by the evaluation. Align with window replacement for cost efficiencies and building envelope integrity when practical. Inspect annually and repair locally as needed using general maintenance funds. Keep the wood siding painted to protect the wood from decay caused by water. Another item that greatly influences useful life is the thoroughness of the original painting. Wood siding will last longer if each piece was painted on all six sides. Typically wood siding is painted on the two sides that are exposed and not on the back ends or top. Since we perform only a visual review we were unable to confirm the extents of the painting. It is reasonable to presume that not all six sides are painted. If the siding is not painted on all sides water can infiltrate and be absorbed into the wood on the unpainted sides which over time will lead to cupping warping and decay limiting its useful life.
