**River Valley Ranch Master Association  
Carbondale, CO**

Report #: 11619-0  
Beginning: January 1, 2022  
Expires: December 31, 2022

**RESERVE STUDY  
Update "With-Site-Visit"**

October 19, 2021

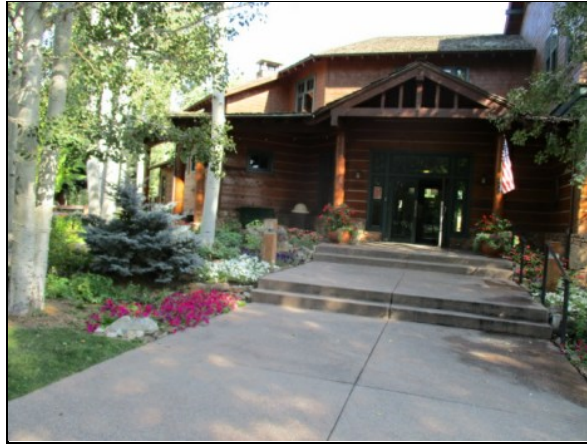
Comments: It was reported that the entry walkways have a snowmelt system. We did not have access to inspect the snowmelt lines. This component funds for the removal and replacement of the snowmelt lines that lay beneath the concrete. Over time the lines will deteriorate and will need to be replaced. This project will include tearing out the concrete removing and re-laying the lines. Snowmelt systems should be inspected regularly and repaired as-needed by serving vendor or maintenance staff to ensure proper function and optimal performance. Minor repairs such as pump/motor replacements electronic system parts etc. should be considered an Operating expense. Plan to replace the entire system at the approximate interval shown below based on our experience and research with similar systems. Total life span can vary based on level of use preventive maintenance quality of materials and installation etc. The snowmelt system revolves around keeping the top surface warm enough to melt falling snow when it contacts the surface instead of letting it pile up. The two popular types of heating systems both work by generating radiant heat underneath the concrete thus keeping the pavement warm during snowstorms. The first heating method uses an electric current to generate heat on a wire or across a mat in almost exactly the same manner as most indoor floor-heating systems. The second method uses a series of tubes and pumps to move hot water directly underneath the driveway warming it up.

Useful Life:  
30 yearsRemaining Life:  
6 years
