**River Valley Ranch Master Association  
Carbondale, CO**

Report #: 11619-0  
Beginning: January 1, 2022  
Expires: December 31, 2022

**RESERVE STUDY  
Update "With-Site-Visit"**

October 19, 2021

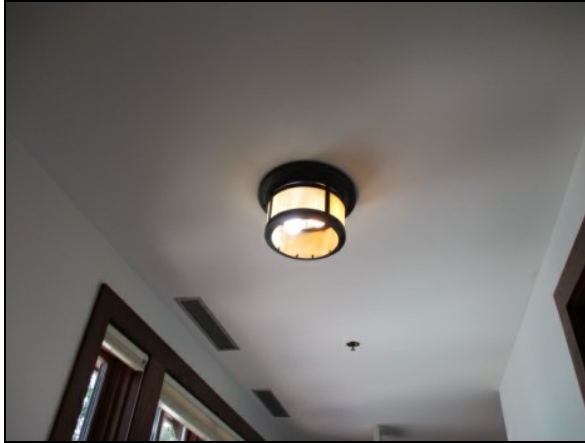
**Comp #: 24030 Interior Lights - Replace****Quantity: ~ (53) Lights**

Comments: Includes (6) Hallway, (6) Grand Room, (13) Lobby/Juice Bar, (10) Bathrooms, (3) Lobby Hall, (2) Mailroom and Foyer, (5) Stairwells, (8) Conference Room. Interior wall lights were noted to be in fair condition with no significant damage/deterioration observed or reported to us. As routine maintenance inspect repair and change bulbs as needed. Best practice is to coordinate at same time as other interior projects (especially painting) whenever possible to minimize downtime and maintain consistent quality standard. Timing of replacements is ultimately subjective. Estimates shown here are based on our experience with similar properties and general aesthetic qualities. A wide variety of fixture styles is available funding recommendations are based on replacement with comparable quality fixtures.

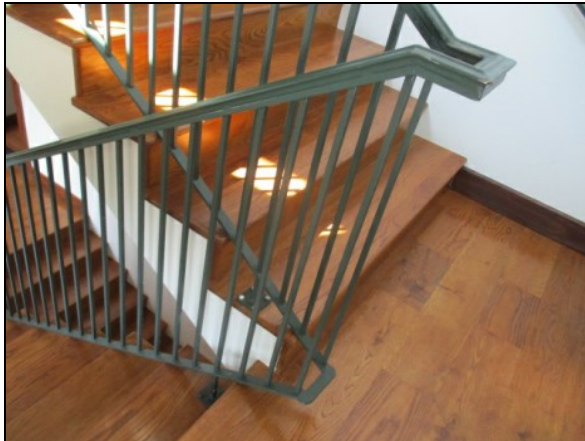
Comments: The finish on the surfaces appeared in fair condition. Minimal evidence of cracking fading and peeling of the paint was observed. No structural issues were reported to us by the client at the time of the inspection. We recommended setting aside reserve funds to supplement the operating budget for local repairs in future years. As routine maintenance inspect regularly and perform any needed local repairs promptly as general maintenance expense. Ensure that tread connections are tight secure and slip resistant. Paint components regularly along with building interiors.

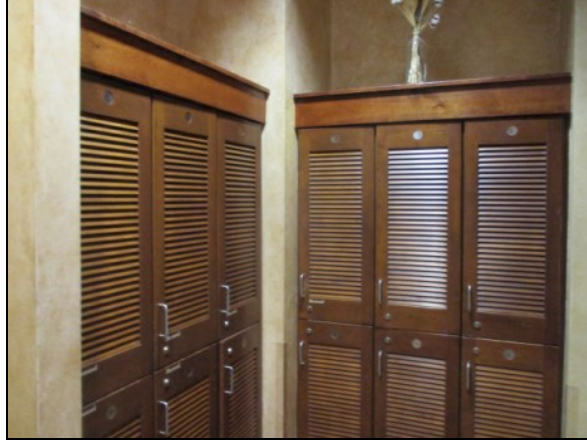
**Comp #: 24050 Lockers - Replace****Quantity: ~ (86) Lockers**

Comments: Lockers determined to be in fair condition typically exhibit some amount of surface wear and/or rusting, but remain in serviceable and generally decent aesthetic condition. Clean and inspect regularly, change lock cylinders, lubricate hinges and repair as needed from Operating budget. Structures located inside protected interior areas can have very long life expectancies. In our experience, it is prudent to expect replacement at the approximate interval shown below in order to maintain good appearance consistent with other interior areas. Timing of replacements is ultimately subjective.

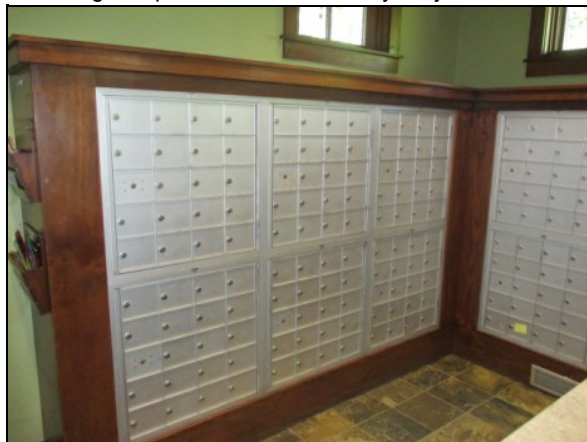
**Comp #: 24060 Mailboxes - Replace****Quantity: ~ (22) Boxes**

Comments: Includes (18) Mailboxes, (4) Parcel Boxes. Increased remaining useful life after visual inspection. Mailboxes determined to be in fair condition typically exhibit some amount of surface wear and/or rusting but remain in serviceable and generally decent aesthetic condition. Clean and inspect regularly change lock cylinders lubricate hinges and repair as needed from Operating budget. Metal mailbox structures located inside protected interior areas can have very long life expectancies. In our experience it is prudent to expect replacement at the approximate interval shown below in order to maintain good appearance consistent with other interior areas. Timing of replacements is ultimately subjective.

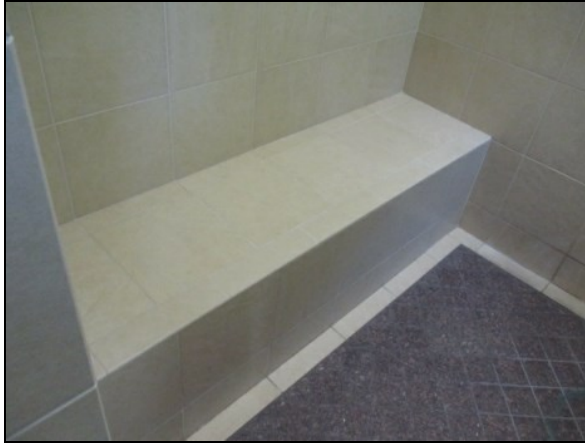
Comments: Client noted no problems with component. Tiled steam rooms were determined to be in fair condition. Floors did not exhibit any extensive un-even or broken sections. No evidence of heavy deterioration or broken tiles. As part of ongoing maintenance program, inspect regularly, repairing or replacing damaged sections as needed. If available, best practice is to keep a collection of replacement tiles on hand for partial replacements. With ordinary care and maintenance, tile in interior locations can last for an extended period of time, but replacement is often warranted eventually to enhance and restore aesthetic appeal in the common areas. Replacement costs can vary greatly depending on size and type of tiles selected. Our recommendation is to replace at the approximate schedule shown here, but this schedule can be adjusted at the client's discretion. "

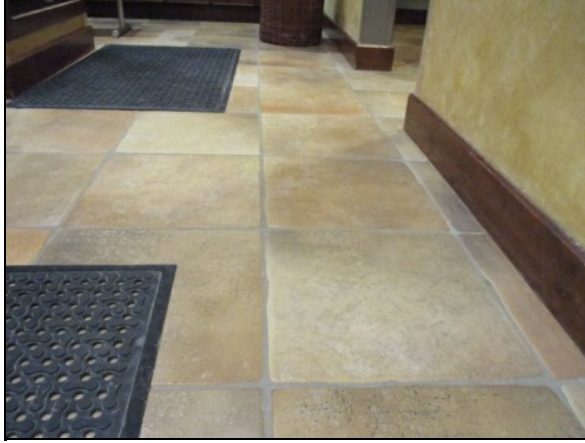
**Comp #: 24070 Tile Flooring - Replace****Quantity: ~ 830 GSF**

Comments: Includes (162 GSF) Juice Bar, (252 GSF) Lobby Hall, (120 GSF) Office 1, (180 GSF) Mailroom, (112 GF) Foyer. Tiled surfaces were determined to be in fair condition. Floors did not exhibit any extensive un-even or broken sections. No evidence of heavy deterioration or broken tiles. As part of ongoing maintenance program inspect regularly repairing or replacing damaged sections as needed. If available best practice is to keep a collection of replacement tiles on hand for partial replacements. With ordinary care and maintenance tile in interior locations can last for an extended period of time but replacement is often warranted eventually to enhance and restore aesthetic appeal in the common areas. Replacement costs can vary greatly depending on size and type of tiles selected. Our recommendation is to replace at the approximate schedule shown here but this schedule can be adjusted at the client's discretion.

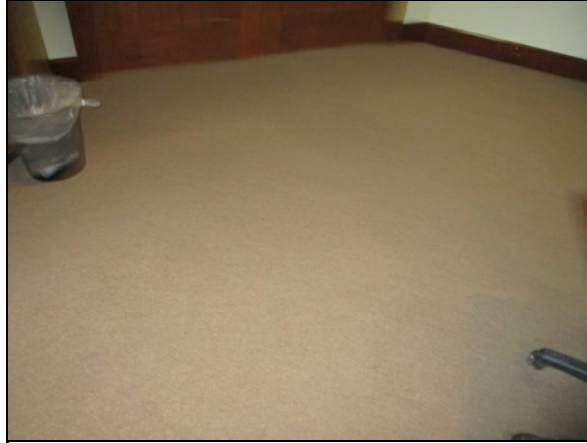
**Comp #: 24080 Carpeting - Replace****Quantity: ~ 369 GSY**

Carpeted surfaces were determined to be in fair condition. Minor evidence of staining matting or loose seams observed. As part of ongoing maintenance program vacuum regularly and professionally clean as needed. Best practice is to coordinate at same time as other interior projects whenever possible to minimize downtime and maintain consistent quality standard. Timing and interval is somewhat subjective but not as flexible as other flooring finishes (tile wood etc.). Estimates shown here are based on our experience with similar properties and general aesthetic qualities. Schedule can be updated/adjusted at the discretion of the client for planning purposes.

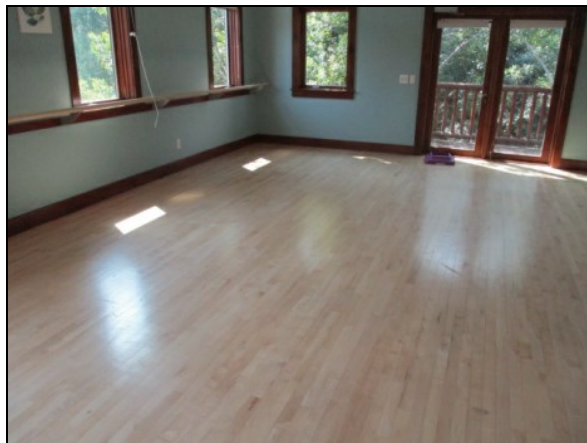
**Comp #: 24090 Wood Flooring - Replace****Quantity: ~ 3700 GSF**

Comments: Includes (736 GSF) Yoga Room, (182 GF) Fitness Room, (1000 GSF) Lobby, (784 GSF) Grand Room, (140 GSF) Lobby Hall, (350 GSF) Stairs. Wood floors were determined to be in fair condition. Floors did not exhibit any extensive un-even or broken sections. No evidence of heavy deterioration. At longer intervals wood flooring may eventually be replaced due to wear and deterioration as well as for aesthetic changes in the common areas. Estimates shown here are based on our experience with similar properties and general aesthetic qualities. Schedule can be updated/adjusted at the discretion of the client for planning purposes.

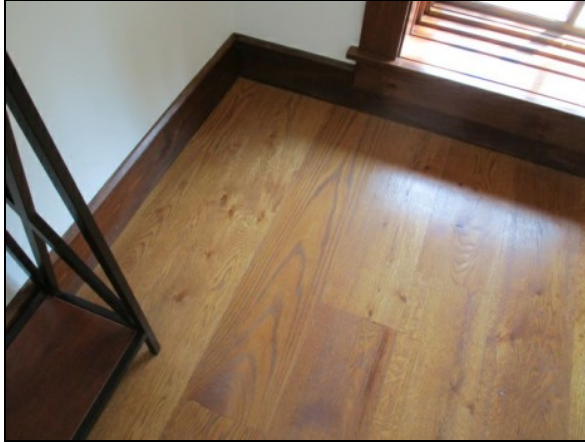
Comments: Wood surfaces were determined to be in fair condition. Minor evidence of staining observed. Wood flooring should be refinished periodically to restore appearance and prolong total life of the surface prior to replacement.

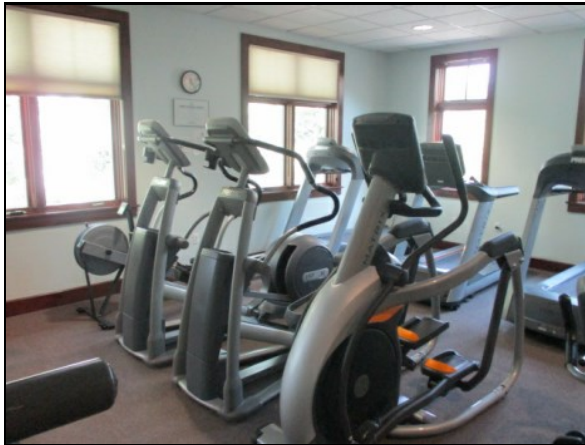
**Comp #: 24150 Fitness Equipment (All) - Replace****Quantity: ~ (43) Pieces**

Fitness equipment determined to be in fair condition is typically commercial grade and in serviceable condition. Heavily-used equipment may show more signs of wear but all equipment is still assumed to be functioning properly and up to an appropriate standard for the property.

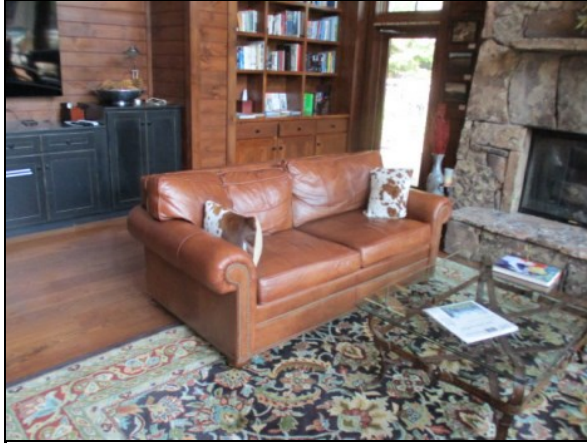
Comments: Includes (3) Lamps, (5) Tables, (17) Chairs, (13) Lounge Chairs, (1) Couch, (8) Barstools, (1) Conference Table found in the clubhouse. The furniture and decor appeared in fair condition. No damage fading or outdated appearances of the furniture was observed. This component recommends funding for periodic replacement/refurbishment of interior furnishings and decor such as furniture artwork window treatments misc. decorative items etc. in order to maintain a desirable aesthetic in the common areas. Cost estimates can vary greatly depending on the amount of items to be replaced at each project and the style and quality of replacement options. Best practice is to coordinate this type of project with other interior projects such as flooring replacement painting etc. Schedule and cost estimates should be re-evaluated during future Reserve Study updates and adjusted as needed based on the client's good judgment.

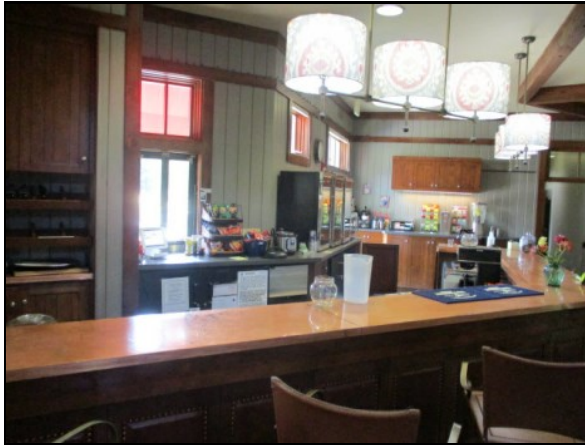
Comments: Includes (68) GSF of Copper Countertop. Countertop was observed to be in fair condition and with proper maintenance can last upwards of 70 years. Expect the need to maintain the counter from the ongoing operating account.

Maintenance includes standard cleaning procedures as well as polishing on a regular basis. Counters and cabinets were clean and mostly free of issues. Fixtures appeared to be in fair condition. Kitchen materials typically have an extended useful life. However many clients choose to refurbish the kitchen periodically for aesthetic updating. This may include refurbishment/refinishing of kitchen cabinets and countertops replacement of sinks installation/replacement of under-cabinet lighting etc. Should ideally be coordinated with replacement of the kitchen appliances. Best practice is to coordinate this project with other amenity areas such as bathrooms or other amenity rooms.

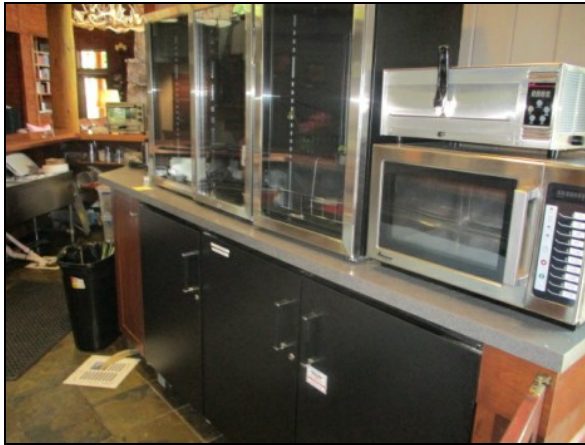
**Comp #: 24260 Commercial Appliances – Replace**

Individual appliances were not tested during inspection and are assumed to be in functional operating condition unless otherwise noted. Useful life can vary greatly depending on level of use quality care and maintenance etc. Funding recommendation shown here is for replacing with comparable quality commercial-grade appliances. Costs shown here include replacement of all appliances at one time. Minimal or no subjective/aesthetic value for commercial kitchen appliances. Useful life is based primarily on normal expectations for service/performance life in this location. Unless otherwise noted remaining useful life expectancy is based primarily on original installation or last replacement/purchase date our experience with similar appliances and assuming normal amount of usage and good preventive maintenance.

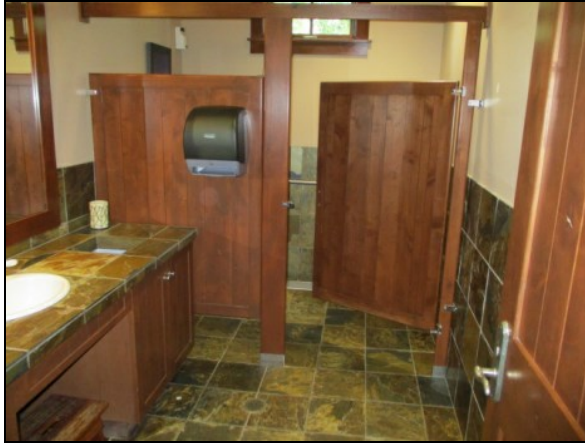
Comments: Includes (2) Lobby Bathrooms, (2) Pool Locker Rooms. Bathrooms were determined to be in fair condition. Flooring did not exhibit any un-even or broken sections. Fixtures appeared to be in slightly outdated condition but no major issues observed. As routine maintenance inspect regularly and perform any needed repairs promptly utilizing general Operating funds. Typical remodeling project can include some or all of the following replacement of plumbing fixtures partitions countertops lighting flooring ventilation fans accessories decor etc. Best practice is to coordinate this type of project with other areas whenever possible. Schedule and cost estimates should be re-evaluated during future Reserve Study updates and adjusted as needed based on the client's good judgment.

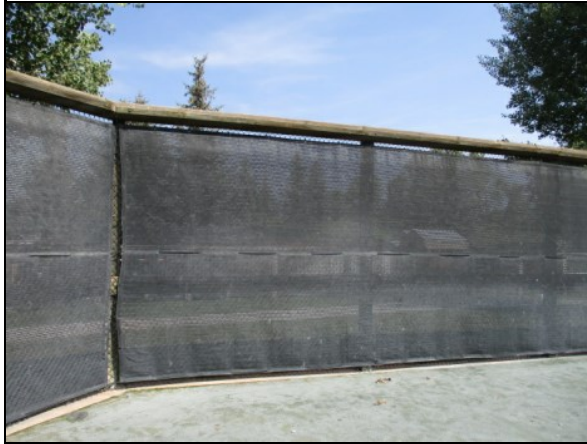
**Comp #: 26160 Tennis Court Windscreen - Replace**

Comments: Poor condition noted with evidence of ripping, tearing, and damage/deterioration observed. Tennis court windscreens should be inspected periodically, especially where attached to the chain link to identify and repair any rips or tears.

Loose/sagging/faded sections should be replaced to maintain good aesthetic appearance in the common areas. Plan to replace all areas together at the approximate interval shown here to maintain consistent appearance.

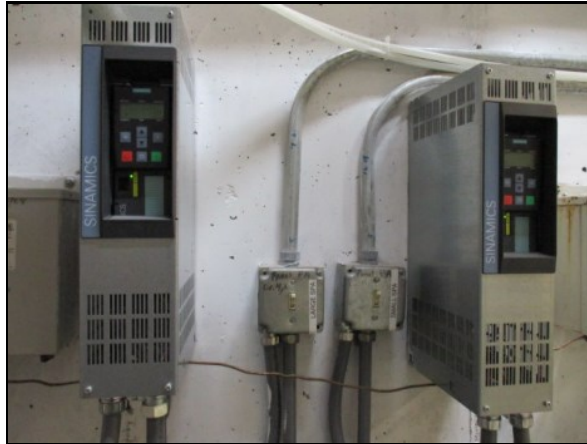
**Comp #: 25300 Poo/Spa VFD - Replace****Quantity: ~ (5) VFDs**

Comments: Includes (4) Siemens Sinamics VFD (M: G120), (1) Danfoss VFD VLT Aquadrive. Minimal or no subjective/aesthetic value for this component. Useful life is based primarily on normal expectations for service/performance life in this location. Unless otherwise noted, remaining useful life expectancy is based primarily on original installation or last replacement/purchase date, our experience with similar systems/components, and assuming normal amount of usage and good preventive maintenance. Variable frequency drives (AKA variable speed drives) are used to control output of mechanical equipment when full power is not required at all times. Should be inspected and repaired as needed by servicing vendor to ensure proper function and optimal performance. Unless otherwise noted, assumed to be functional and in good condition. Plan to replace at the approximate interval shown below. The payback period for these systems, measured in energy savings, is often a fraction of the design life of the unit itself.

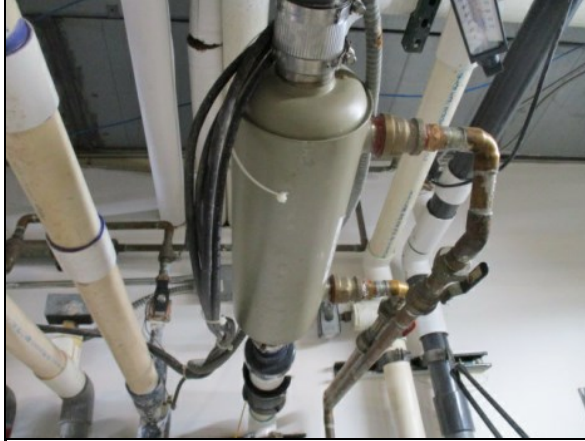
**Comp #: 25490 Pool/Spa Heat Exchangers - Replace**

Comments: Includes (3) In-Line Heat Exchangers. Minimal or no subjective/aesthetic value for this component. Useful life is based primarily on normal expectations for service/performance life in this location. Unless otherwise noted, remaining useful life expectancy is based primarily on original installation or last replacement/purchase date, our experience with similar systems/components, and assuming normal amount of usage and good preventive maintenance. Variable frequency drives (AKA variable speed drives) are used to control output of mechanical equipment when full power is not required at all times. Should be inspected and repaired as needed by servicing vendor to ensure proper function and optimal performance. Unless otherwise noted, assumed to be functional and in good condition. Plan to replace at the approximate interval shown below. The payback period for these systems, measured in energy savings, is often a fraction of the design life of the unit itself.

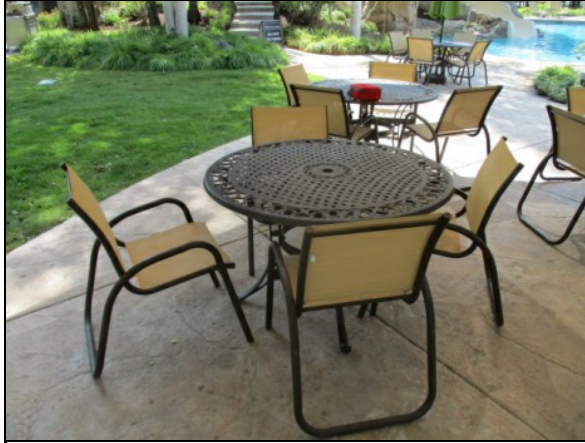
**Comp #: 28040 Pool Deck Furniture - Replace****Quantity: ~ (140) Pieces**

The furniture appeared in fair condition. No damage fading or outdated appearances of the furniture was observed. We recommend regular inspections and repair or replacement of any damaged pieces promptly to ensure safety. Protected storage of furniture when not in use can help to extend useful life. Best practice is to replace all pieces together in order to maintain consistent style and quality in the pool/recreation area. Costs can vary greatly based on type of pieces selected for replacement. Funding recommendation shown here is based on replacement with comparable number and quality of pieces.

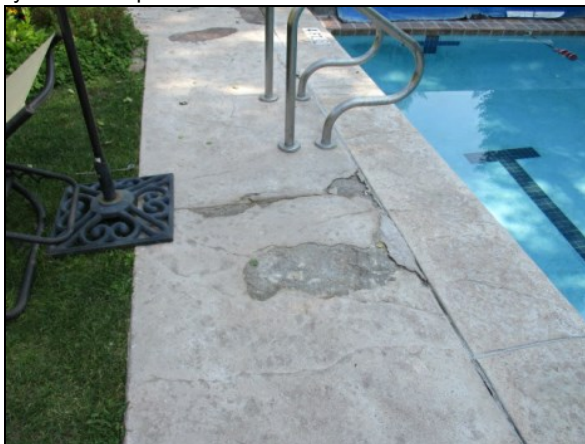
**Comp #: 28050 Deck - Seal/Repair****Quantity: ~ 10100 GSF**

Comments: Decking was observed to be in poor condition. Deck was exhibiting major signs of wear and/or age. Pool decks may be exposed to harsh chemicals that can leave stains if not addressed properly. Periodic pressure-washing and repairing will restore the appearance and prolong the need for major restoration or replacement of the deck surface. Take note of any places where water is ponding which may result in slip-and-fall hazards if not corrected.

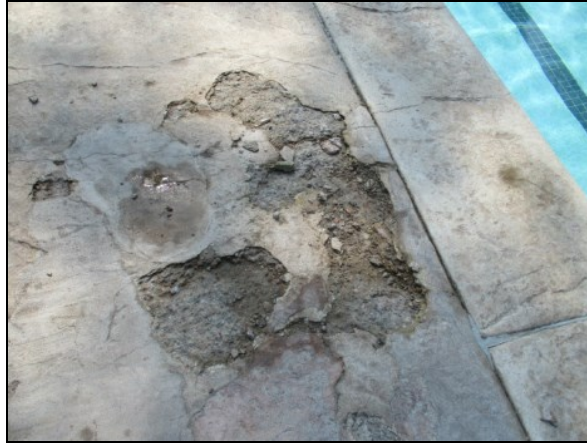
Comments: Client noted problems with the seal and therefore, advanced resurface needs are common. Component is an allowance to maintain pool decking aesthetics as it deteriorates progressively. Decking was observed to be in fair condition. The concrete surfaces exhibited hairline cracking shrinkage and settlement cracking. These issues can result in water entry to the base which can ultimately lead to trip hazards. Pool decks may be exposed to harsh chemicals that can leave stains if not addressed properly. Periodic pressure-washing and re-coating will restore the appearance and prolong the need for major restoration or replacement of the deck surface. Take note of any places where water is ponding which may result in slip-and-fall hazards if not corrected.

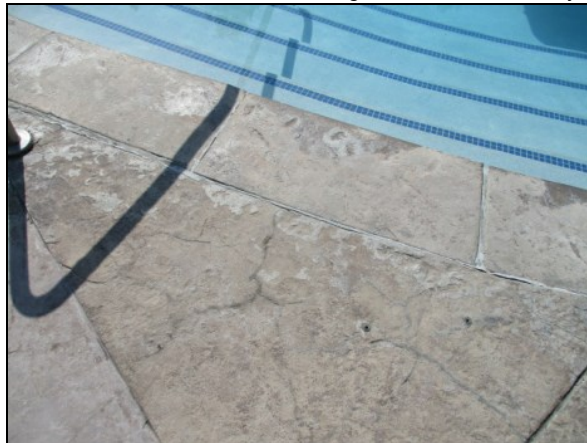
**Comp #: 28090 Coping Stones - Repair****Quantity: ~ 670 LF**

Comments: Includes (262 LF) Lap Pool, (251 LF) Main Pool, (118 LF) Zero Degree Pool, (12 LF) Small Spa, (25 LF) Large Spa. Coping stones were observed to be in fair condition. The concrete surfaces exhibited minor hairline cracking and with some shrinkage and settlement cracks observed which can result in water entry to the base which can ultimately lead to trip hazards. Although complete replacement of all areas together should not be required conditions observed merit inclusion of an allowance for ongoing repairs and partial replacements. Exposure to sunlight weather and frequent vehicle traffic can lead to larger more frequent repairs especially for older properties. Inspect all areas periodically to identify trip hazards or other safety issues. Timeline and cost ranges shown here should be re-evaluated during future Reserve Study updates.

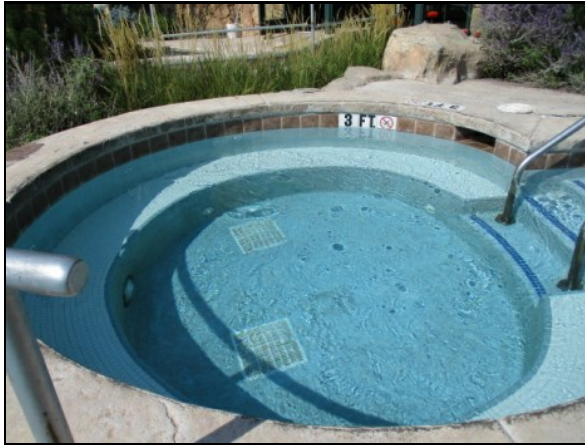
Comments: Includes (262 LF) Lap Pool, (251 LF) Main Pool, (118 LF) Zero Degree Pool, (12 LF) Small Spa, (25 LF) Large Spa. Pool/Spa was observed to be in fair condition. Pavers exhibited minor cracking. Appearance was noted to be upholding appropriate aesthetic standards for the property. Small repairs to waterline tile should be done as needed as an Operating expense. Complete re-tiling is warranted at longer intervals to restore the look and feel of the interior finish. While drained for resurfacing any other repairs to lighting handrails stairs ladders etc. should be conducted as needed. This type of project is best suited for slow/offseason to minimize downtime during periods when pool is used heavily. Should be expected at the approximate interval shown below to preserve this important amenity of the client.

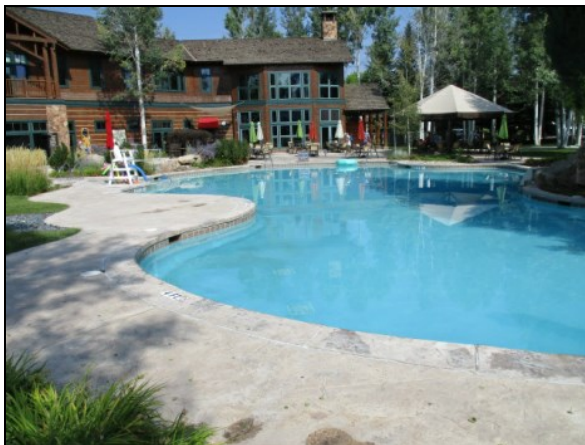
Comments: Includes (7685 GSF) Lap Pool, (10077 GSF) Main Pool, (1436 GSF) Zero Degree Pool.. Pool surfaces exhibited some pitting chipping un-even and broken surfaces. Cracks were observed to be substantial. Pool resurfacing will restore the aesthetic quality of the pool while protecting the actual concrete shell of the pool from deterioration. While drained for resurfacing any other repairs to lighting handrails stairs ladders etc. should be conducted as needed. This type of project is best suited for slow/offseason to minimize downtime during periods when pool is used heavily. Should be expected at the approximate interval shown below in some cases schedule may need to be accelerated due to improper chemical balances or aesthetic preferences of the client.

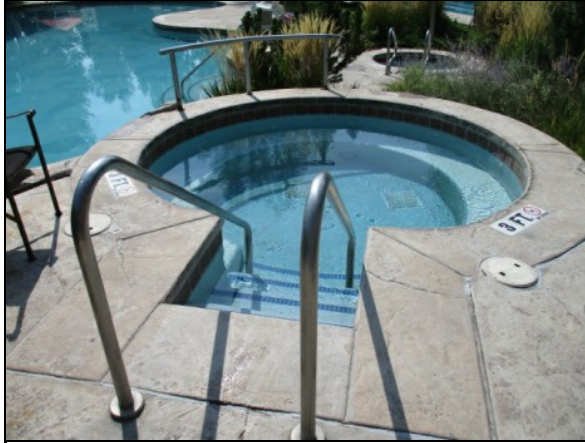
Comments: Client reported that spas need to be resurfaced as soon as possible. At least (1) spa is planned for replacement because of code issues in having intake and output piping too close to each other. No estimate for replacement was given.

Includes (1) Small Spa (11 GSF) (1), Large Spa (49 GSF). Spa surfaces exhibited some pitting chipping un-even and broken surfaces. Cracks were observed to be substantial. Spas sometimes need to be resurfaced more frequently than pools due to higher chance of chemical imbalances. Whenever possible both should be done at the same time to achieve better pricing and minimize downtime. While drained for resurfacing any other repairs to lighting handrails stairs ladders etc. should be conducted as needed. This type of project is best suited for slow/offseason to minimize downtime during periods when spa is used heavily.

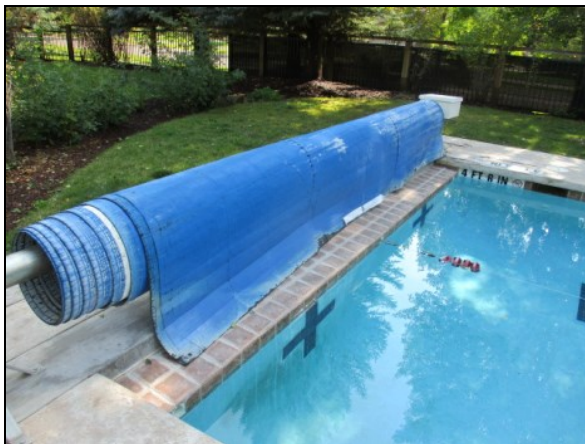
**Comp #: 28140 Pool Cover - Replace****Quantity: ~ (1) Cover**

Comments: Cover was observed to be in poor condition. Tattered and frayed construction observed. Fabric was noted to be faded with ripping observed. Inspect regularly and properly store when not in use. Cover can provide cost savings for temperature differentials reduce cleaning costs and provide safety. We suggest planning to replace at regular intervals to maintain proper functionality.
